**WATER**  
**SENSE**

**Tukituki**  
**Land Care**  
**Makara Catchment**  
**Summary report**  
**to August 2025**

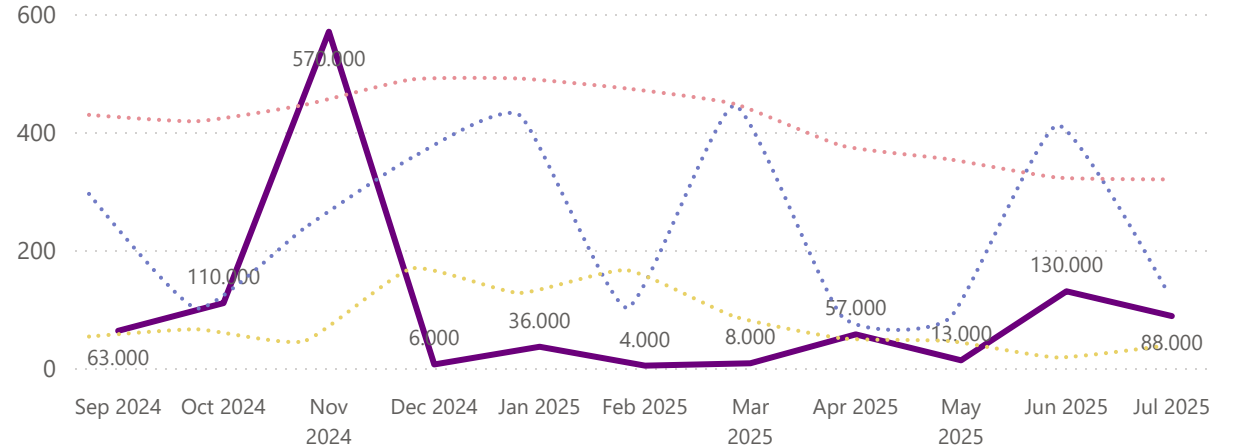
E. coli
