Tukituki Land Care

Kahahakuri

SUB-CATCHMENT PLAN: SUMMARY

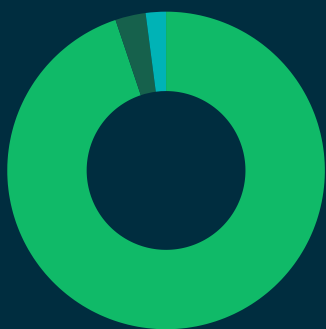
- Pasture
- Orchard and Vineyards
- Indigenous Forest

92 percent of the catchment is in pasture, three percent in orchard and vineyards and two percent in indigenous forest.

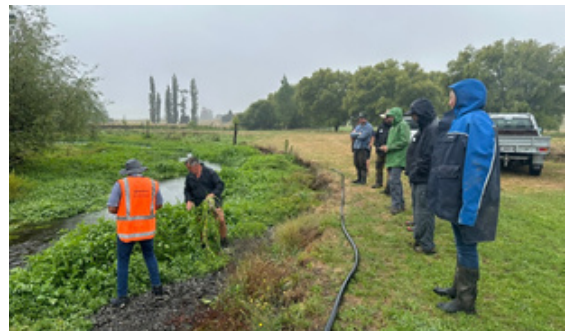
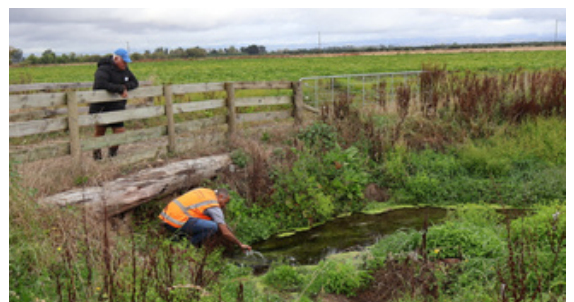
In 2024, TLC facilitated a visit to the catchment by scientists from Massey University, local farmers and regional council representatives. They assessed the extent of cow cress spread, streambank erosion, and sediment movement in the waterways. Through water quality sampling and catchment data analysis, they identified that high nutrient levels in the water contribute to cow cress's rapid growth. They also found that erosion and sediment transport are being worsened by past flooding events, particularly in the middle and upper reaches of the stream.

Following this assessment, the Massey team analysed river flow data, historical land use patterns, and digital elevation models (LiDAR) to better understand erosion processes and how sediment moves through the catchment. This work has helped pinpoint where erosion is most active and where interventions like riparian planting, sediment traps, and erosion control structures could be most effective. Massey also provided insights into the best ways to manage cow cress, drawing on experiences from other parts of New Zealand. They recommended a combined approach, including;

- carefully planned mechanical removal to clear problem areas while minimising bank disturbance,
- selective herbicide trials to test the effectiveness of different spray options in controlling cow cress while maintaining stream health,
- riparian planting with native sedges to shade out cow cress and stabilise stream banks,

With support from a TLC Demonstration Grant, a multi-pronged approach is now being tested to manage cow cress and improve waterway health. These trials are designed to find cost-effective and scalable solutions that can be used by other farmers facing similar issues.
