Tukituki Land Care

Mangatarata

SUB-CATCHMENT PLAN: SUMMARY

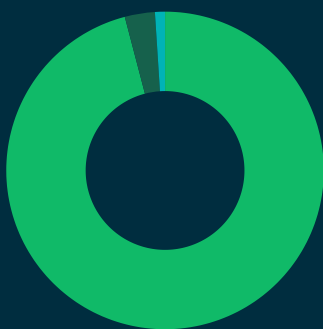
94 percent of the catchment in pasture, three percent in exotic forest and less than one percent in indigenous forest.

- Pasture
- Exotic Forest
- Indigenous Forest
