## MAKARORO SUB-CATCHMENT PLAN DRAFT

TLC The Big Picture: Tackling the big issues sub-catchment by sub-catchment

# MAKARORO SUB-CATCHMENT: CONTEXT AND CHALLENGES

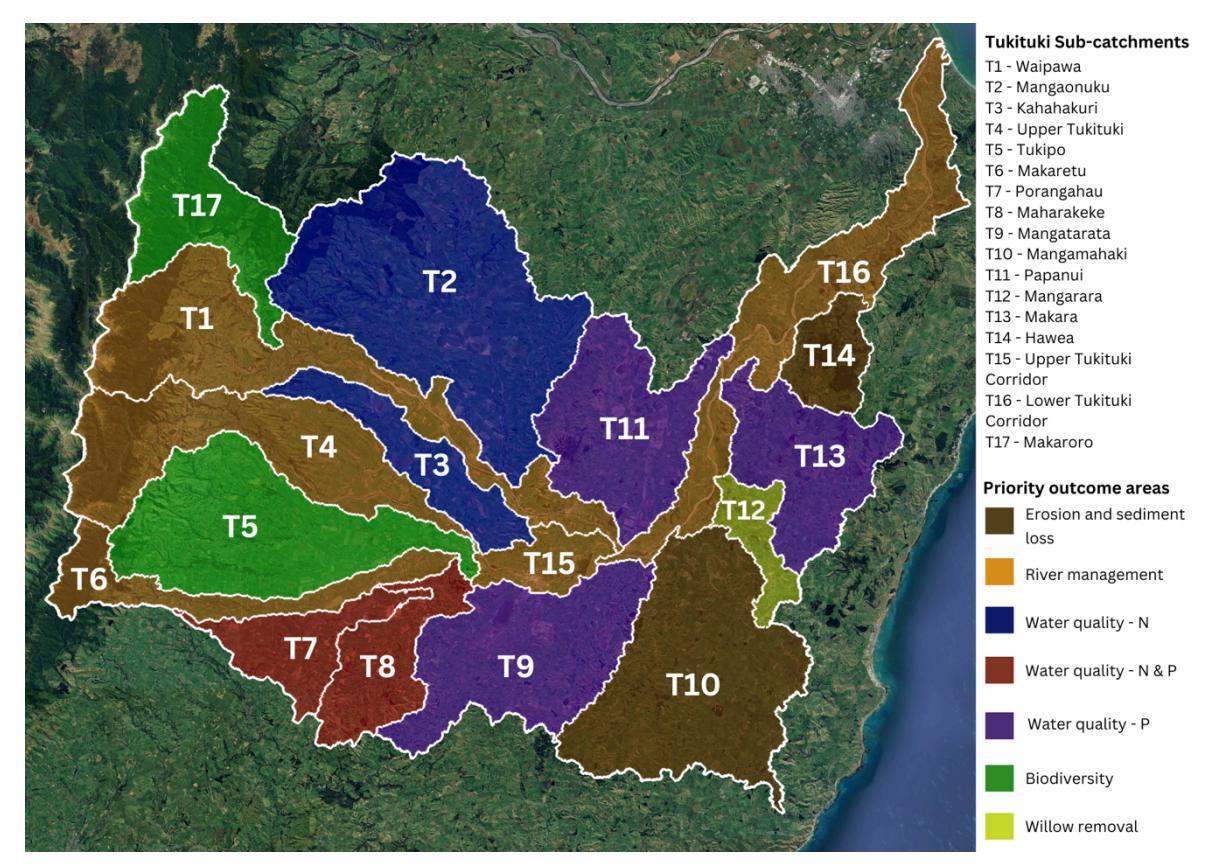
Figure 1 – Sub-catchment map for the Tukituki cathment. Coloured areas highlight the recommended priorities for each sub-catchment.

The Big Picture project team has worked with farmers to identify challenges and opportunities in each of the 17 sub-catchments. While each sub-catchment has an individual plan, it is the big picture of the people, the land and the water within the Tukituki that we are trying to collectively support. The approach is reminiscent of a jigsaw puzzle where many pieces fit together and form something greater than themselves as an individual piece. Figure 1 below shows how the Tukituki sub-catchments fit together as a big picture, showing the sub-catchments that are aligned in similar top priorities. Note that the image only shows the proposed highest recommended priority area for each sub-catchment, and all sub-catchments will have multiple outcomes they are seeking.

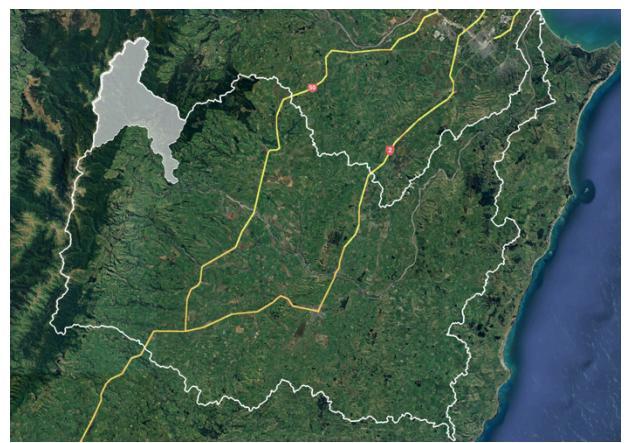
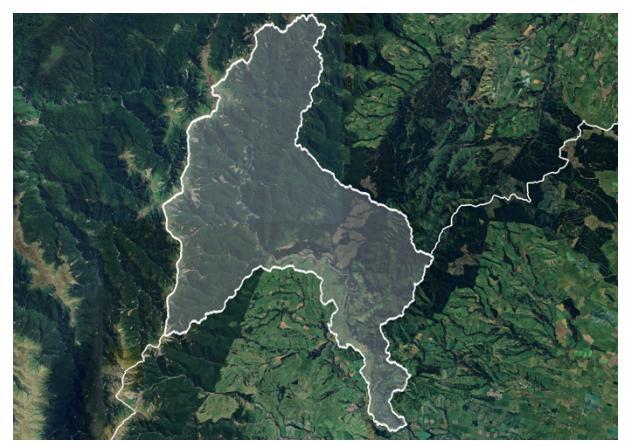
Figure 1 - Location of the Makaroro sub-catchment in the wider Tukituki catchment

The Makaroro sub-catchment, located in southern Hawke's Bay, plays a crucial role in local farming and water management. The Makaroro River originates from the Ruahine Range, flowing southeast before joining the Waipawa River near Tikokino. This river has been at the centre of discussions around water security, particularly with the proposed Ruataniwha Water Storage Scheme<sup>1</sup>. This project aimed to create a 93-million-cubic-metre reservoir to support irrigation and regional water supply. While the scheme was shelved, recent legislative changes may bring it back into discussion, potentially impacting water availability for farmers in the area.

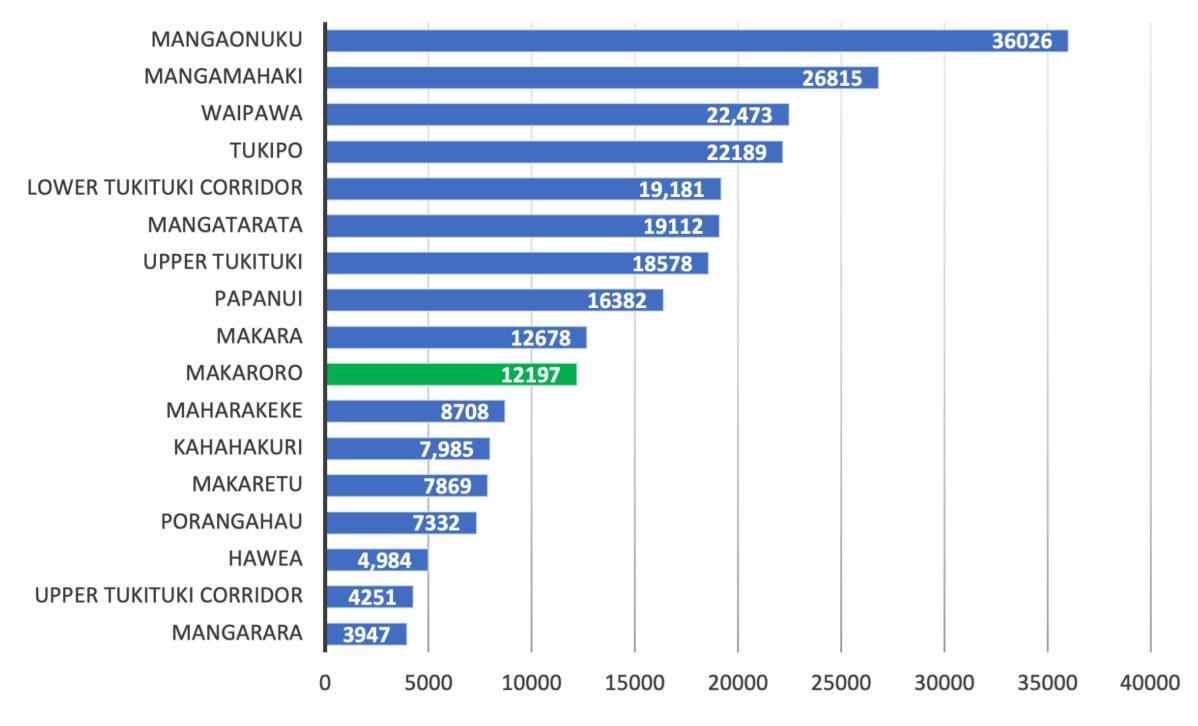
Figure 3 – Tukituki sub-catchment areas in hectares.

The Makaroro sub-catchment is 12,197ha, 4.88% of the wider Tukituki catchment. The Makaroro is a moderate-sized sub-catchment of the Tukituki, which is 250,000ha (Figure 3).

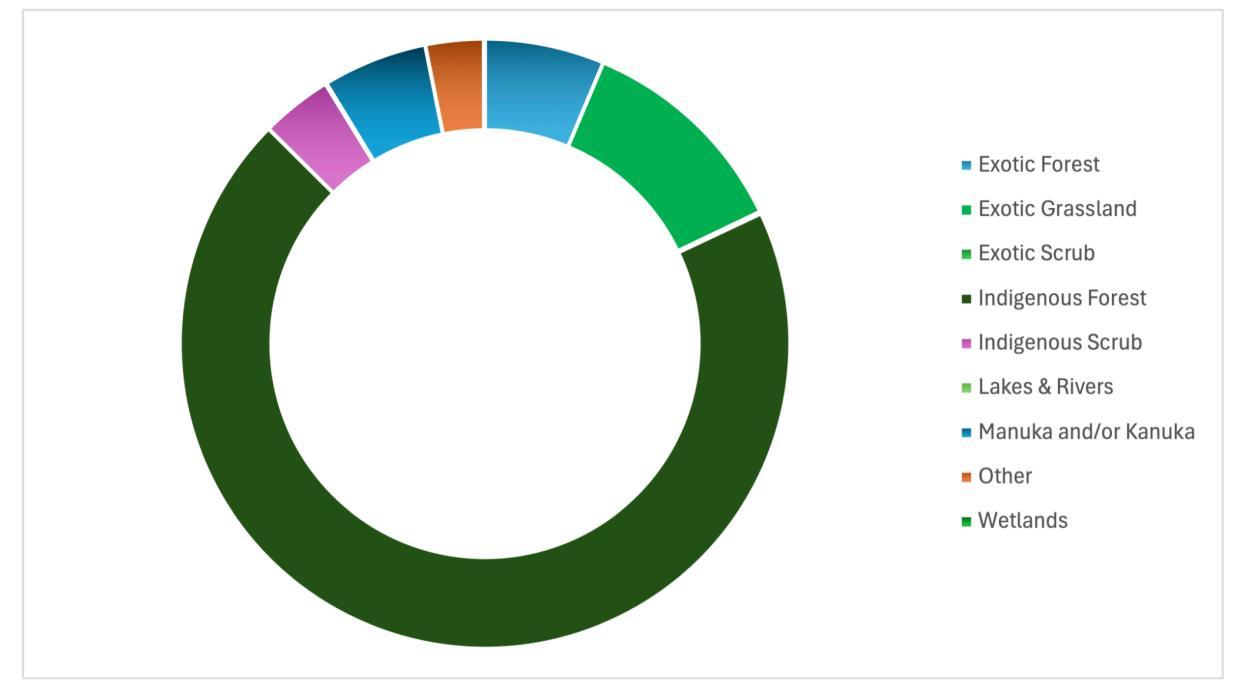
Figure 4 – Land use in the Makaroro sub-catchment.

Land use in the Makaroro is untypical of the wider Tukituki catchment with 69% of the sub-catchment in indigenous forest and 12% in pasture. Less than 6% of land cover is in exotic forest and either manuka or kanuka scrub (Figure 4).

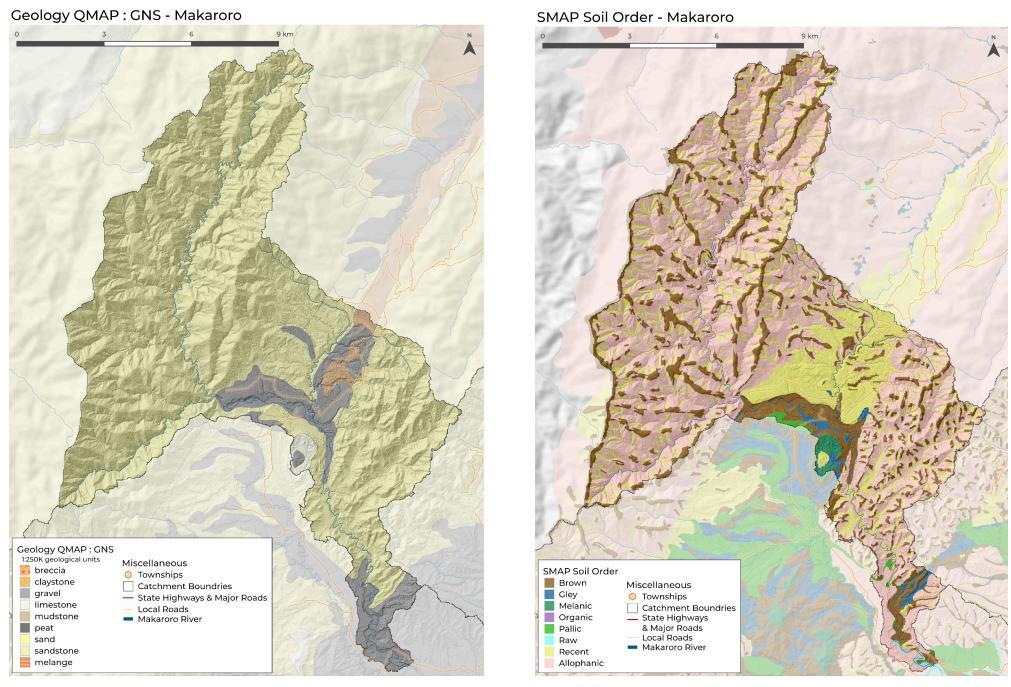
Figure 5 – Left: Geology of the Makaroro sub-catchment.

Figure 6 – Right: Soil orders of the Makaroro sub-catchment.

The Makaroro sub-catchment is different to many of the sub-catchments in the Tukituki catchment. It is one of the steepest sub-catchments, the most forested, the soil is different than the other sub-catchments and has the highest amount of indigenous forest (figures 5 to 8).

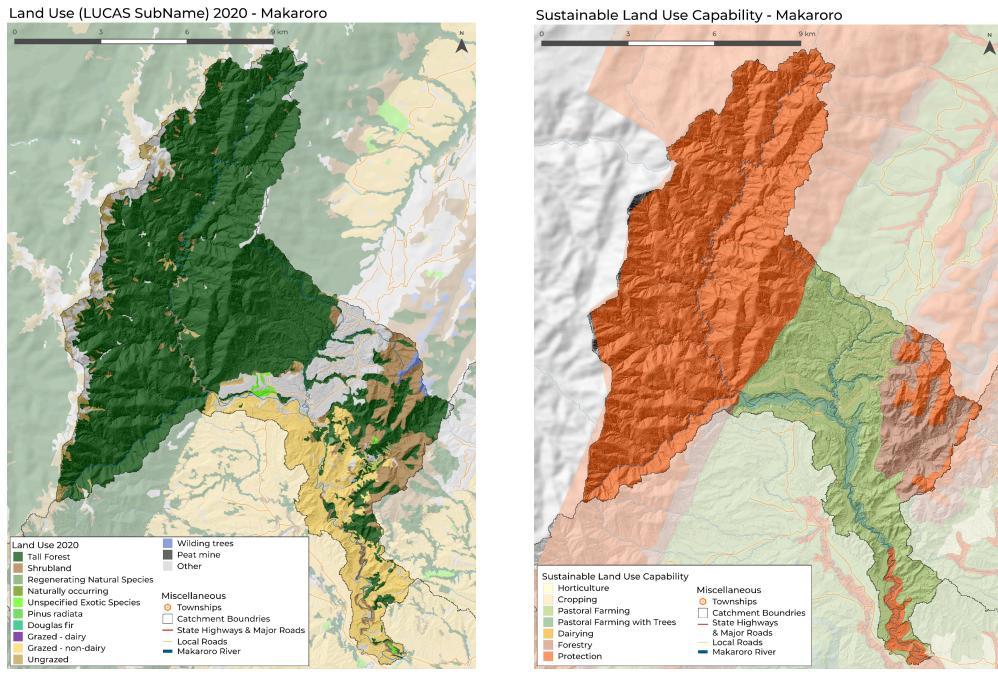
Land Use (LUCAS SubName) 2020 - Makaroro

Figure 7 – Left: Land use in the Makaroro sub-catchment(2020).

Figure 8 – Right: Estimated "appropriate" land use for the Makaroro sub-catchment(HBRC).
