### Tukituki Land Care

# SUB-CATCHMENT PLAN: SUMMARY

### HĀWEA AT A GLANCE

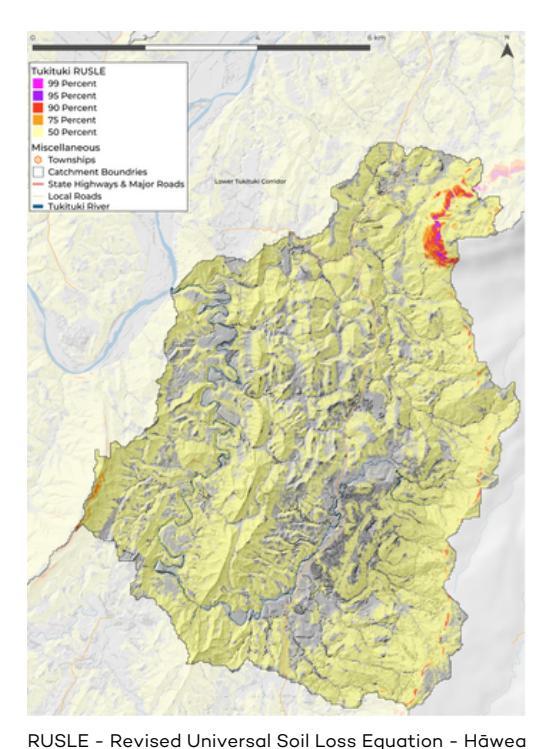
The underlying geology consists predominantly of mudstone and claystone, making the landscape highly susceptible to erosion.

A desktop analysis indicates that most of the catchment is at risk of erosion, with certain areas in the northwest exhibiting significantly higher susceptibility compared to the rest of the catchment.

There is a significant amount of highly erodible land, with most of the catchment in the top 50 percent of erodible land in the Tukituki.

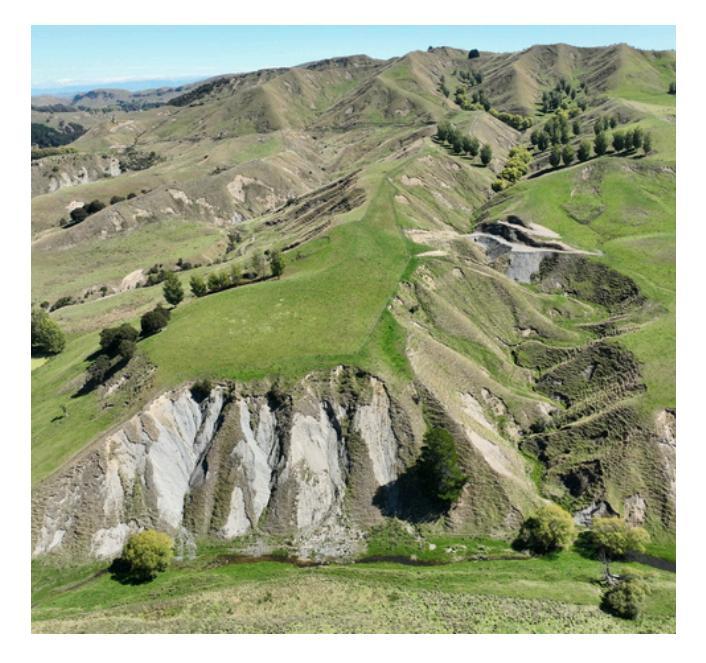
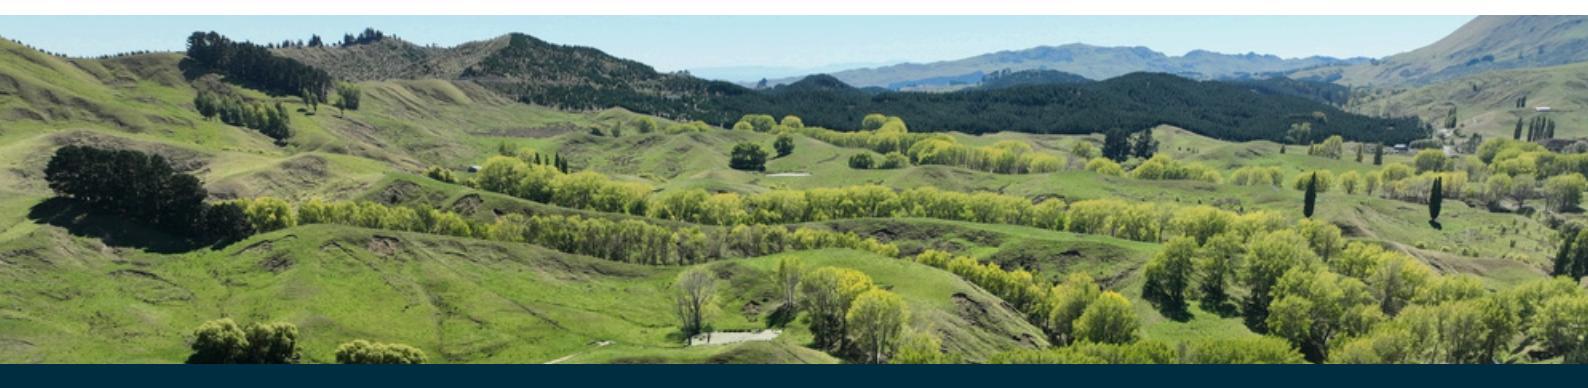
Erosion and sedimentation continue to be significant challenges across the Hāwea catchment, with the aging poplar and willow plantings along waterways also causing problems.

These trees, planted in the 1960s and 1970s across approximately 14 ha on multiple properties, have become a persistent issue in the catchment.

Over time, lack of proper maintenance has weakened the "old man" poplars, making them prone to instability, which increases the risk of tree falls, flood debris, and safety hazards.

Despite these concerns, these trees still play an important role in erosion control, offering benefits such as soil stabilisation, sediment reduction, and potential timber uses.
